# **Assessment of Habitat and Streamflow Requirements For Habitat Protection, Usquepaug–Queen River, Rhode Island, 1999–2000**

By DAVID S. ARMSTRONG and GENE W. PARKER

Open-File Report 02-438

In cooperation with the  
RHODE ISLAND DEPARTMENT OF  
ENVIRONMENTAL MANAGEMENT

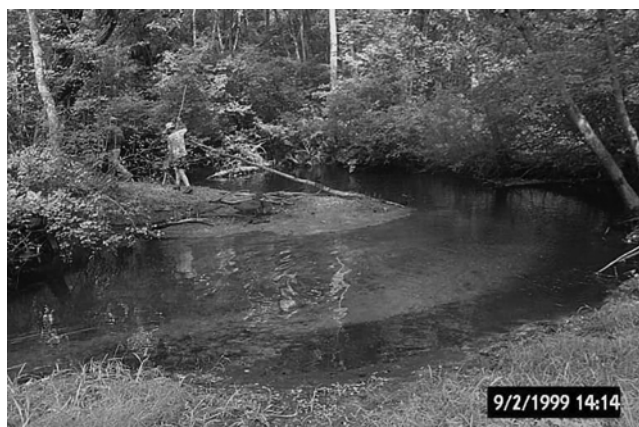
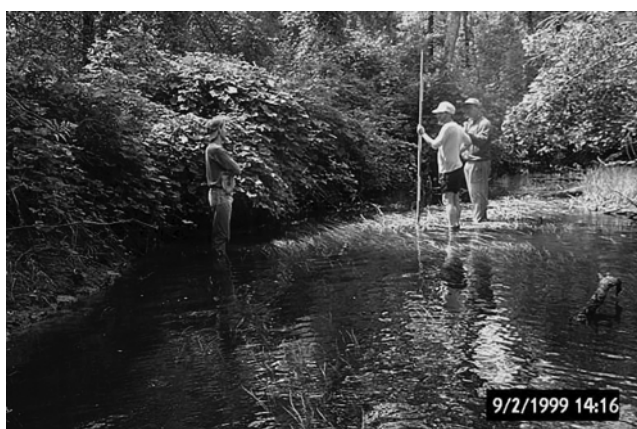
**A.** Bend pool and exposed sandbar, upstream view

**B.** Submerged aquatic vegetation and overhanging vegetation, downstream view

**Figure 4.** Habitat features on the Usquepaug River, near Usquepaug (Site U3) South Kingstown, Rhode Island: (A) bend pool and exposed sandbar, upstream view, and (B) submerged aquatic vegetation and overhanging vegetation, downstream view.

As water levels decline, habitat losses first appear along the margins of sandbars located on the insides of meander bends; however, moderate water depths remain in the pools along the outsides of the meander bends. During very low flows, the run becomes a riffle, and water depths become quite shallow. During extreme low flows, the edge of water pulls away from the banks, and woody debris and vegetated sandbars provides minimal or no cover because of shallow water conditions (fig. 4).

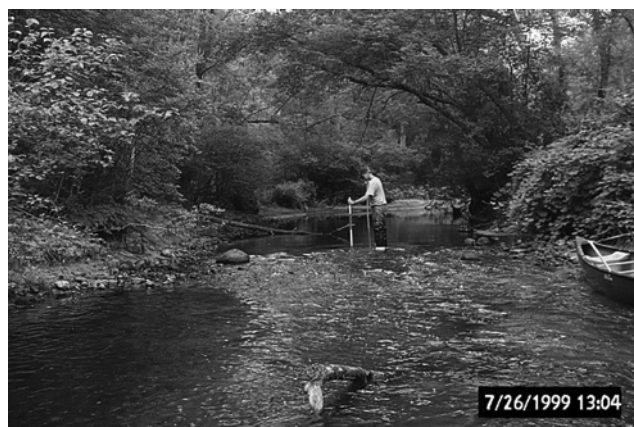
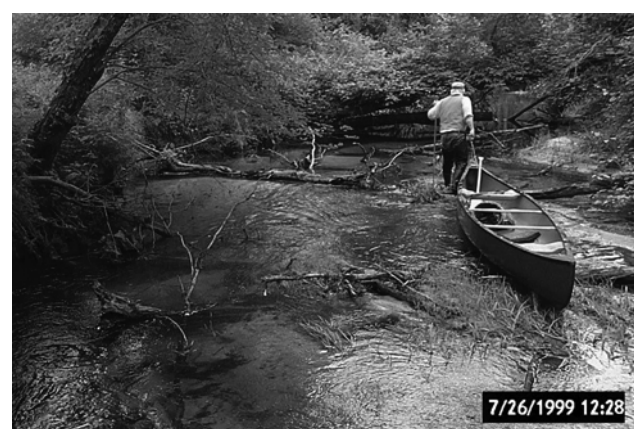
**A.** Riffle and run habitat, upstream view

**B.** Woody debris, downstream view

**Figure 5.** Habitat features on the Usquepaug River near Laurel Lane (Site U2), South Kingstown, Rhode Island: (A) riffle-and-run habitat, upstream view, and (B) woody debris, downstream view.

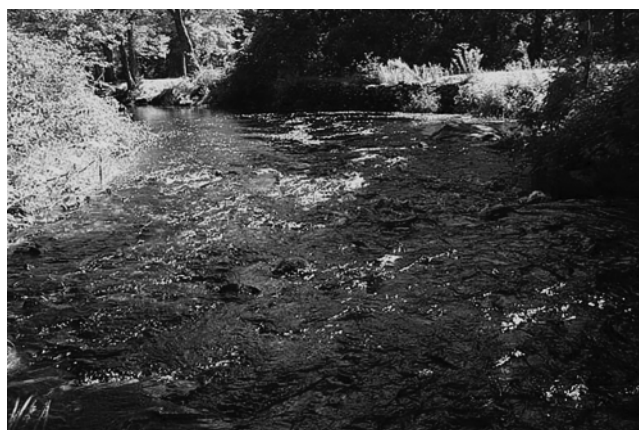
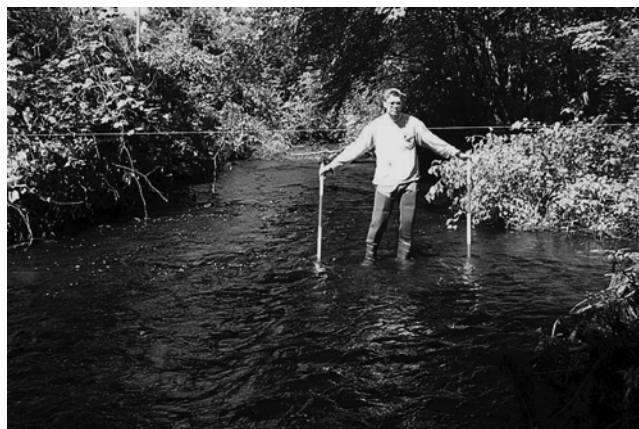
**A.** Riffle habitat, downstream view

**B.** Riffle habitat, upstream view

**Figure 6.** Habitat features on the Usquepaug River at Route 138 (Site U1), South Kingstown, Rhode Island: (A) riffle habitat, downstream view, and (B) riffle habitat, upstream view.

downstream of Glen Rock Reservoir (fig. 6). The channel has a uniform cross section and is 25 to 35 ft wide. The river channel between Old Usquepaug Road and Route 138 is mostly straight, with a slight bend to the left. The channel may have been straightened, and the banks altered as part of a long history of mills and settlement at this location. However, none of the channel alterations appear to be recent. There is a stone wall along the right bank just downstream of Old Usquepaug Road and also upstream of the Route 138 bridge. The right bank has been reinforced with boulder riprap over most of its length, and the riprap is mostly covered with vines and shrubs. In the downstream portion of the reach, the riparian area on the right bank

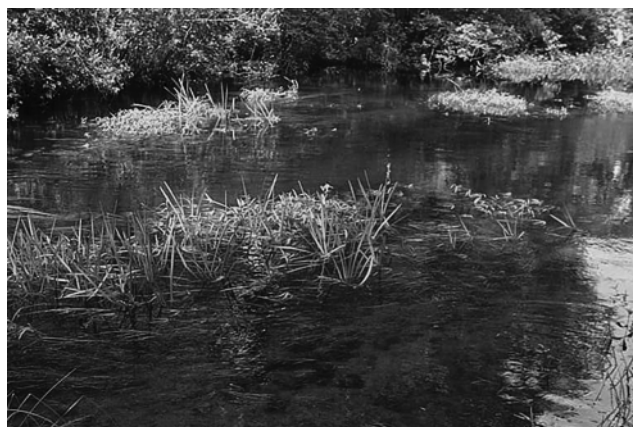
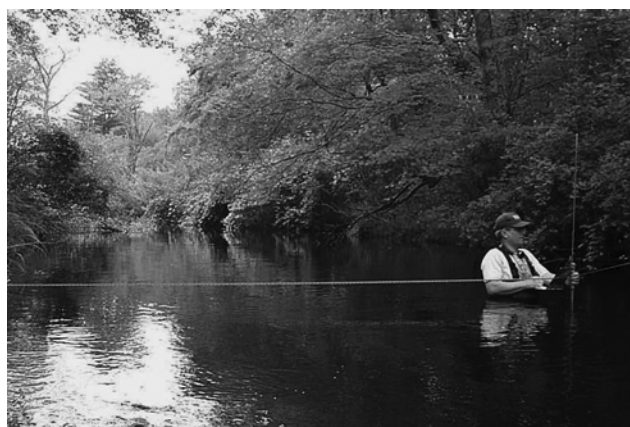
**A.** Vegetated sand bars, upstream view

**B.** Overhanging vegetation and deep pool, downstream view

**Figure 7.** Habitat features on the Queen River near Kingston Road (Site Q8), Exeter, Rhode Island: (A) vegetated sand bars, upstream view, and (B) overhanging vegetation and deep pool, downstream view.

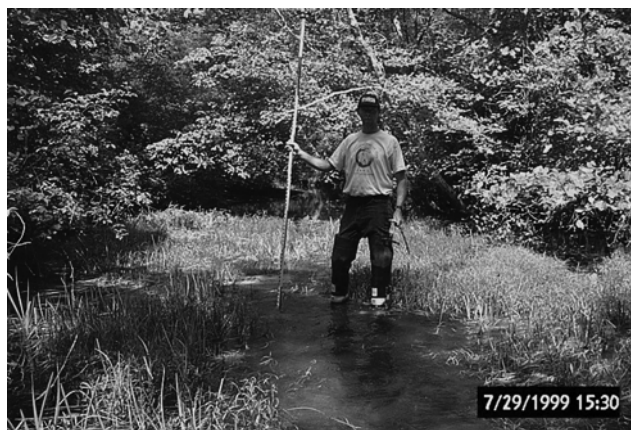
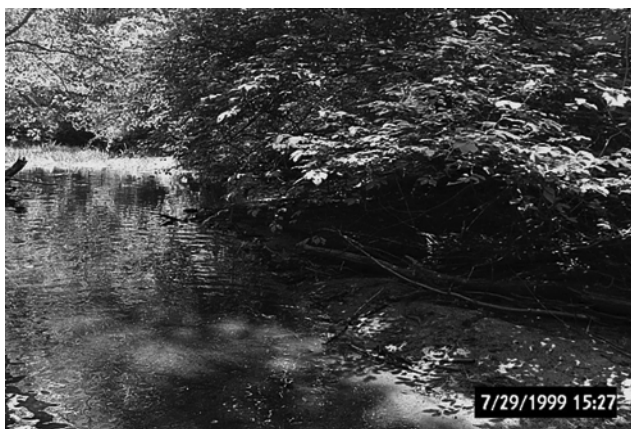
#### A. Vegetated sand bars, upstream view

#### B. Shallow stream margins, downstream view

**Figure 8.** Habitat features on the Queen River at Liberty Road (Site Q7), Exeter, Rhode Island: (A) vegetated sand bars, upstream view, and (B) shallow stream margins, downstream view.

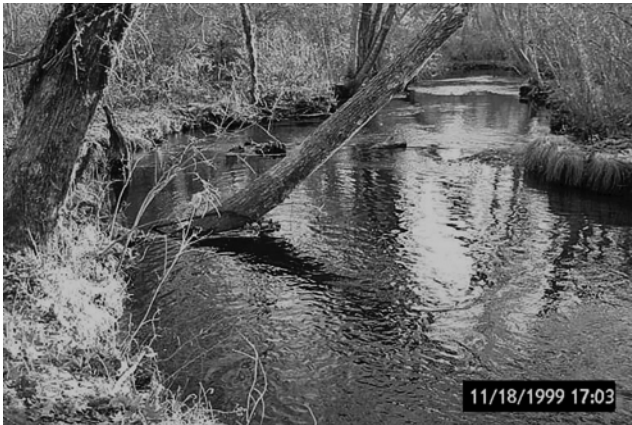
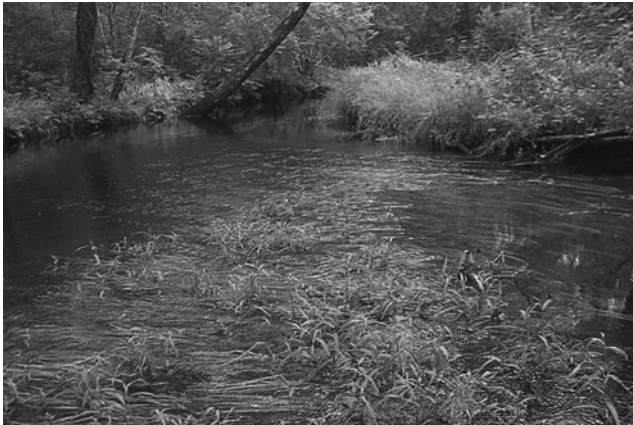
**A.** Undercut trees, downstream view

**B.** Submerged aquatic vegetation, downstream view

**Figure 9.** Habitat features on the Queen River near Dawley Road (Site Q6), Exeter, Rhode Island: (A) undercut trees, downstream view, and (B) submerged aquatic vegetation, downstream view.

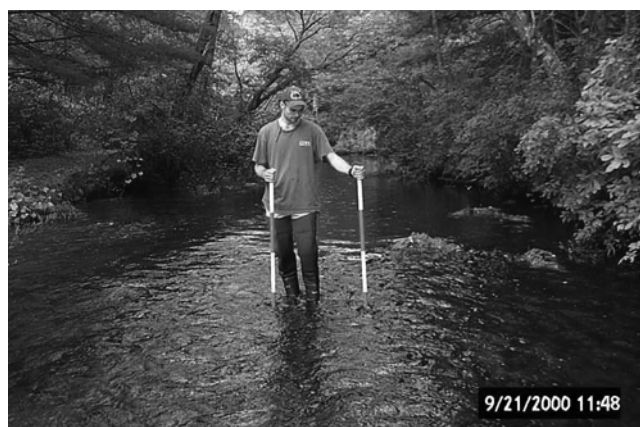
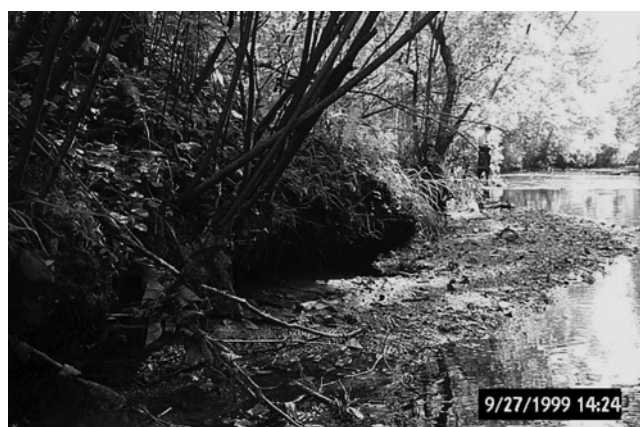
**A.** Riffle, upstream view

**B.** Left bank showing loss of stream-margin habitat at low flows, downstream view

**Figure 10.** Habitat features on the Queen River at Dawley Road (Site Q5), Exeter, Rhode Island: (A) riffle, upstream view, and (B) left bank showing loss of stream-margin habitat at low flows, downstream view.

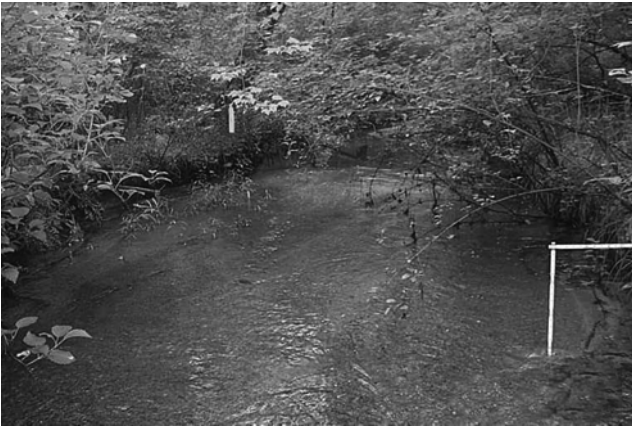
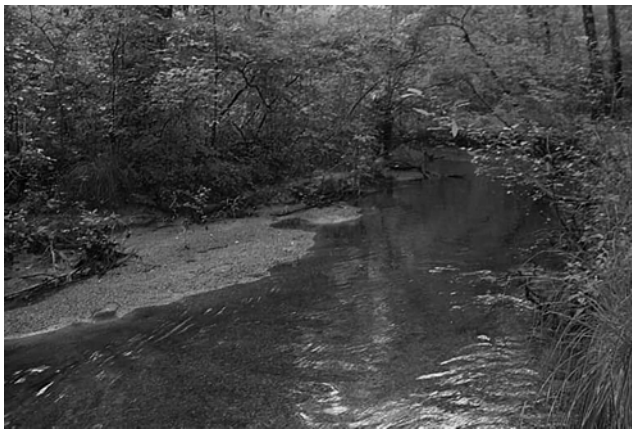
**A.** Shallow water, upstream view

**B.** Loss of habitat at stream margins, upstream view

**Figure 11.** Habitat features on the Queen River near School Land Road (Site Q4), Exeter, Rhode Island: (A) shallow water, upstream view, and (B) loss of habitat at stream margins, upstream view.

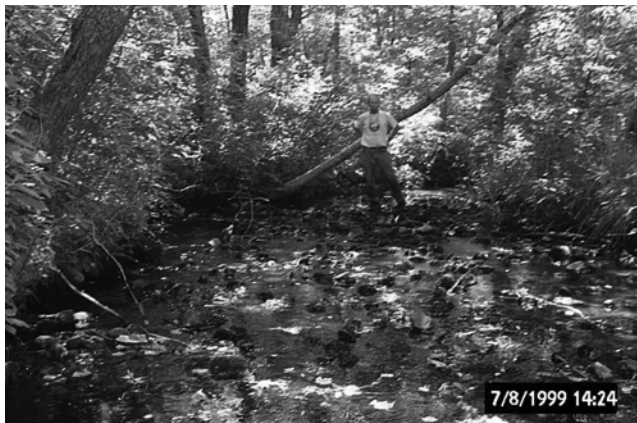
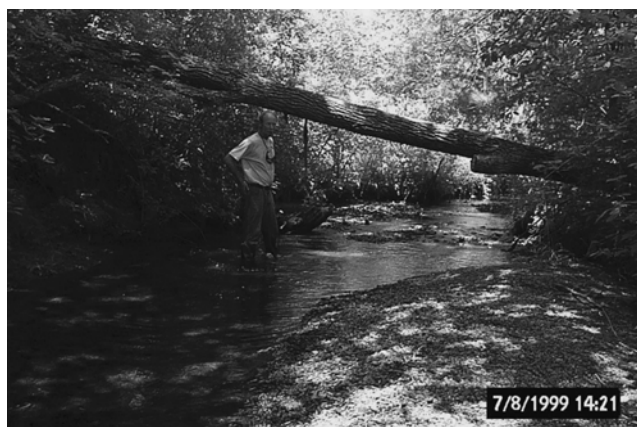
**A.** Riffle with rectangular cross section during low flow, downstream view

**B.** Loss of stream-margin habitat, upstream view

**Figure 12.** Habitat features on the Queen River at William Reynolds Road (Site Q3), Exeter, Rhode Island: (A) riffle with rectangular cross section during low flow, downstream view, and (B) loss of stream-margin habitat, upstream view.

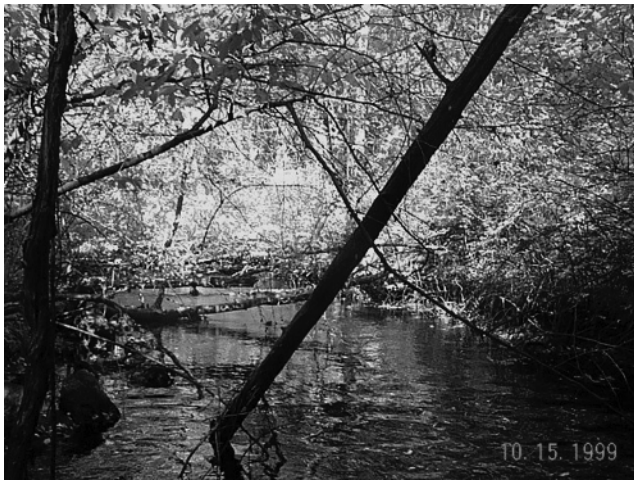
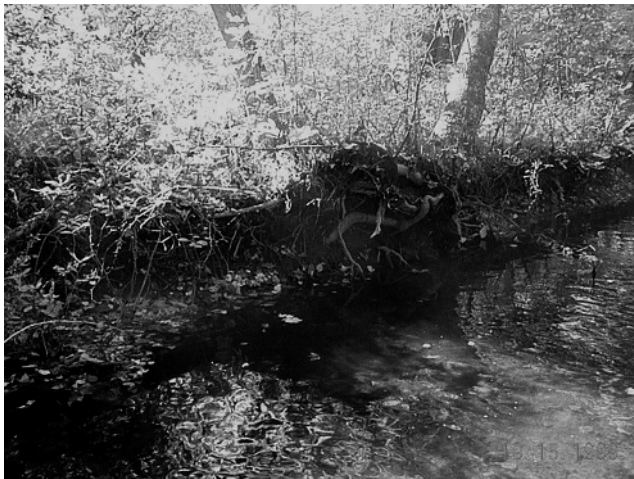
**A. Woody debris, upstream view**

**B. Loss of stream-margin habitat**

**Figure 13.** Habitat features on the Queen River near William Reynolds Road (Site Q2), Exeter, Rhode Island: (A) woody debris, upstream view, and (B) loss of stream-margin habitat.

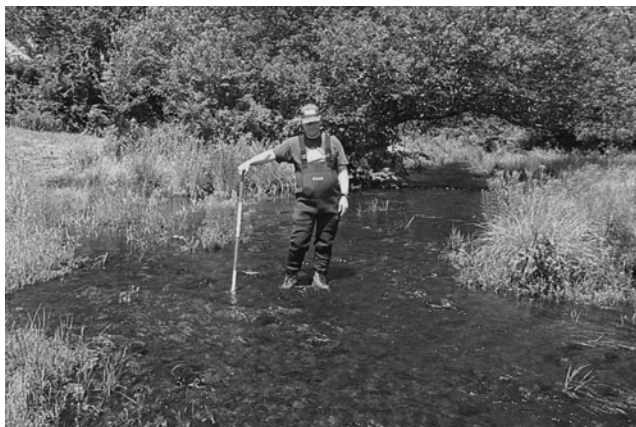
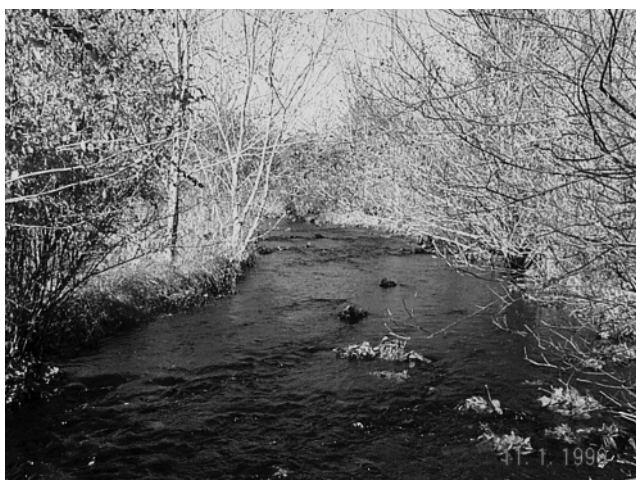
**A.** Riffle, upstream view

**B.** Riffle, downstream view

**Figure 14.** Habitat features on Locke Brook at Mail Road (Site L1), Exeter, Rhode Island: (A) riffle, upstream view, and (B) riffle, downstream view.

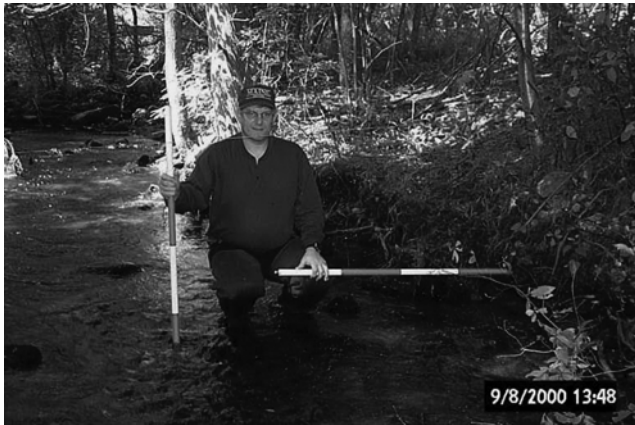
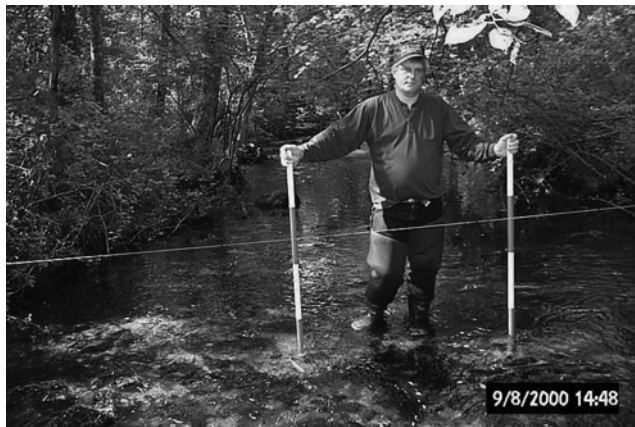
**A.** Riffle, downstream view

**B.** Riffle, downstream view

**Figure 15.** Habitat features on Fisherville Brook at Liberty Church Road (Site F2), Exeter, Rhode Island: (A) riffle, downstream view, and (B) riffle, downstream view.

This reach is about 400 ft downstream of the Liberty Church Road bridge over Fisherville Brook in Exeter. Drainage area to the site is  $8.14 \text{ mi}^2$ . The site begins several hundred feet downstream of the bridge, and extends about 200 ft downstream from the point where a side channel along the left bank joins the main channel. The reach has a moderate gradient and includes several riffles. Although the stream channel appears to be natural, a side channel on the left bank and an old foundation on a hill near the right bank indicate that the stream upstream of the reach may have been altered historically. The brook in this reach is about 20 ft wide and mostly shaded by trees and overhanging shrubs along the forested banks. The reach is predominantly riffle-and-run habitat with a coarse sand, gravel, and cobble streambed. Cover in the riffle is provided by turbulent stream surfaces and velocity shelters behind cobbles, boulders, and woody debris in the channel. Some of the boulders are covered with aquatic moss, which provides habitat for invertebrates. The streambed also contains some metal and other debris. The downstream portion of the reach has several shallow pools and one long pool which has water depths of about 3 ft during low flow. Cover in the pools is mostly provided by water depth, overhanging shrubs, woody debris, and undercut banks (fig. 15).

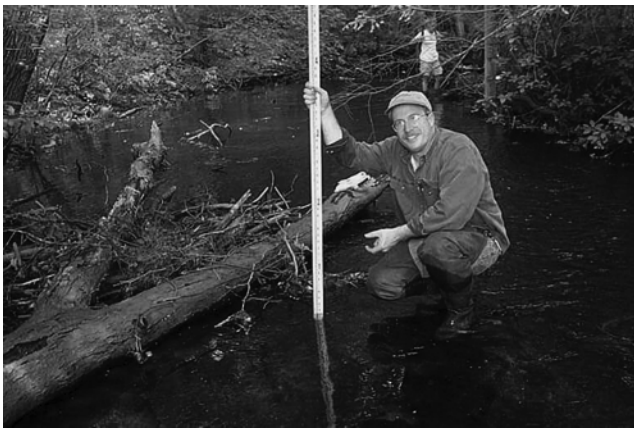
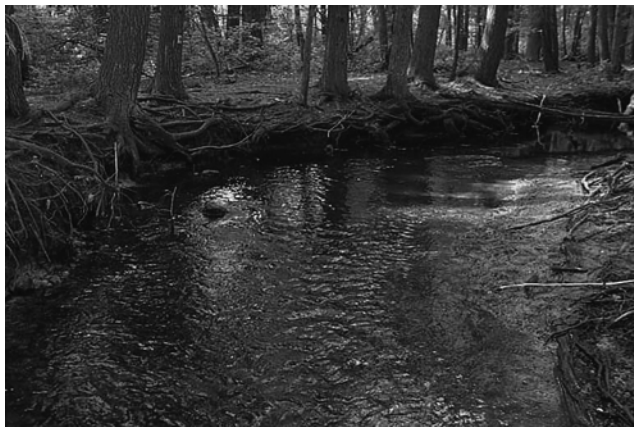
**A.** Woody debris, downstream view

**B.** Run, upstream view

**Figure 16.** Habitat features on Fisherville Brook near Pardon Joslin Road, (Site F1), Exeter, Rhode Island: (A) woody debris, downstream view, and (B) run, upstream view.
